The sinkholes and their appearance in the karstic zones Los socavones y su aparición en los suelos de zonas kársticas

The objective of this work is to study the sudden appearance of a sinkhole in the town of Los Ángeles, belonging to the municipality of Rioverde, SLP, to prevent damage to the patrimony of the families and the infrastructure of the city. The research work consisted of 6 stages: Stage 1, a site visit to gather information about the place and obtain the impressions of the neighbors of the area of analysis (street crossing); Stage 2, sought to verify the topography of the site and locate the sources or bodies of water; Stage 3, consisted in the exploration using the manual dynamic penetrometer (MDP) and the recovery of the integral and unaltered sampling of the site; Stage 4, included the development of conventional geotechnical tests for the characterization of the soils present, determine their moisture profile, as well as determine the possibility of dispersion, suffusion, and collapse. In Stage 5, the stress distribution in the subsoil was modeled and in Stage 6, the conclusions are presented. Through the MDP, an infiltration point was identified at the intersecti

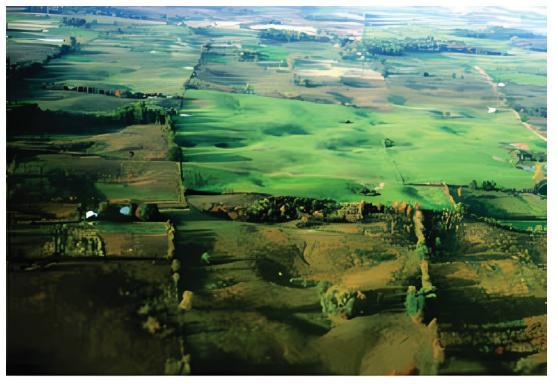
Figure 1. Dolines formed in the subsurface (Britannica, 2021)

Sinkholes generally present conditions that allow the flow of water into the subsoil, because the infiltration zones of the sinkholes are superficial and sometimes these are obstructed by clay plugs, thus forming a body of water, and it is not until the cementing agents of the soil are dispersed with the water that the conduit appears at the bottom of the sinkhole (Britannica, 2021) (Figure 1).

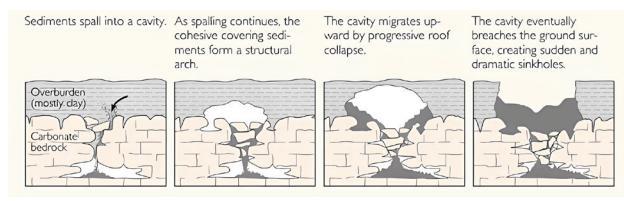
Figure 2. Dynamics of sinkhole formation, (USGS: Science for a Changing the world, 2021)

In arid and semi-arid areas of our planet, it is common to find soils with complex behavior often damaging buildings as a result of the differential movements they cause Ayadat & Hanna; (2011) and Abbaslou *et al.* (2020) and the reason why they are called difficult soils, this is the case of expansive soils, collapsible soils, and landfills (Das, 1999). In collapsible soils, also called metastable soils, it is common to see the sudden appearance of sinkholes (*dolines*) during the rainy season, as a consequence of the destruction of the soil structure when its particles migrate and consequently form conduits and large subway cavities called caverns, caused by the subway flow (Figure 2). Caverns may collapse when the subway weathering process becomes more severe, and due to their size and unstable conditions, thus causing the sudden appearance of a sinkhole, as mentioned by Knodel (1991), and Das (1999) and Abbaslou *et al.* (2016) as shown in Figure 3.

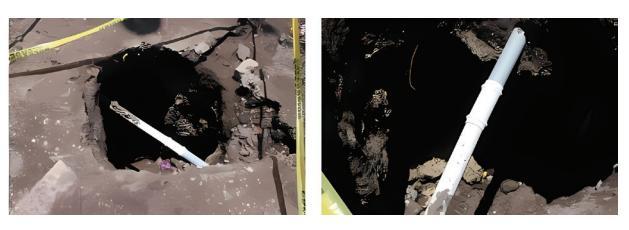
Figure 5. View of the cavity

At the intersection of Miguel Hidalgo St. and Juan de la Barrera St., in the town of Los Angeles, the cavity shown in Figure 5 was identified. Upon inspecting the cavity it was found that it is not regular; on the surface, it had a diameter of approximately 0.80 m, with a visible diameter at the bottom of approximately 2.00 m and 2.80 m in depth.

The bottom of the cavity showed a series of branches mostly directed towards the northeast.

- A truncated conical cavity was located with 0.80 m in diameter on the surface, 2.00 m in diameter at the bottom, and 2.80 m in depth. Inside it showed several ducts of up to 40 cm in diameter, partially obstructed with residues of the collapsed vault; in addition, the soil adjacent to the cavity showed low resistance due to saturation. It was also possible to identify the presence of subway conduits branching in different directions. The main conduit is directed

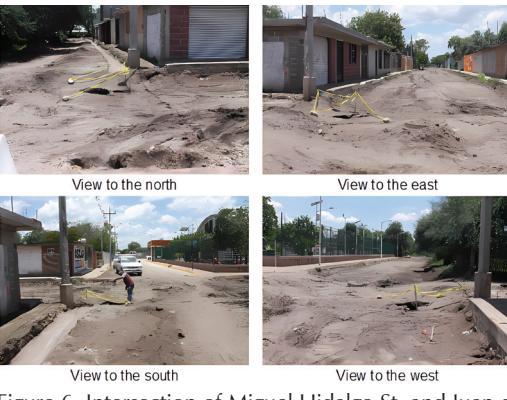
Figure 6. Intersection of Miguel Hidalgo St. and Juan de la Barrera St.

Surface runoff occurs in the North to South and East to West direction, it accumulates at the intersection of the streets as it is the lowest part and it is the place where water infiltration into the subsoil occurs (Figure 6). In addition, the municipal water pipe is located in the upper part of the cavity and the municipal sewage system manhole is located 3.00 m away.

- The slope on the surface of the terrain causes the accumulation of water at the intersection of the aforementioned streets, where the water line and the drainage line also meet, and, in addition, the static level of the water extraction wells is at a depth of 12 meters.
- The soil profile showed five strata at the site of interest; the first stratum goes from the surface to 0.80 m underground and it is a CL-type soil (Low plasticity inorganic clay), the second stratum goes from 0.80 m to 1.40 m underground and it is an ML-type soil (Low compressibility inorganic silt), the third stratum goes from 1.40 m to 2.80 m underground and it

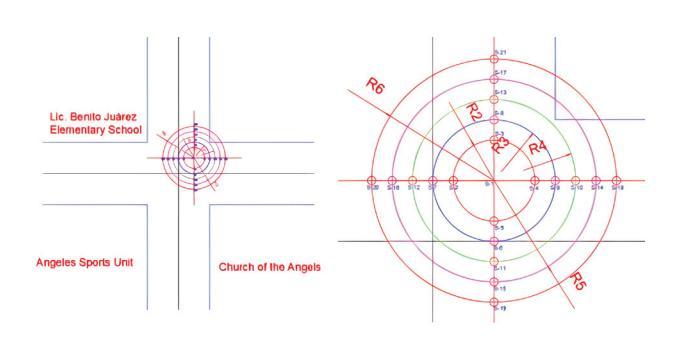
Figure 7. Probes locations performed with $\ensuremath{\mathsf{HDP}}$

To characterize the subsoil of the site, a probing campaign was carried out using the Handheld Dynamic Penetrometer (Figure 7).

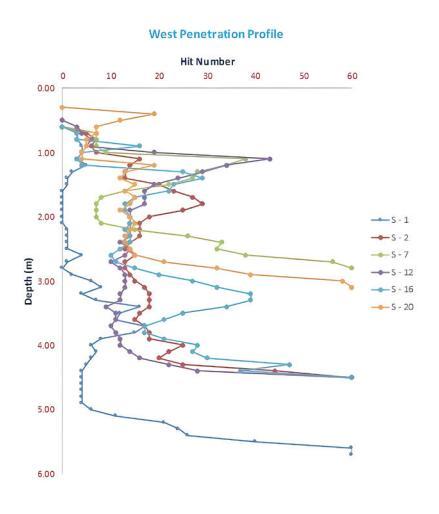
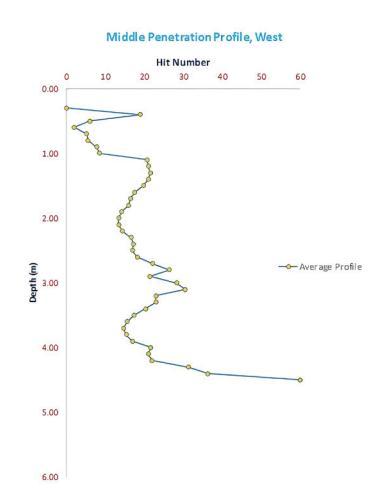
Figure 8. Probes in the west end

The behavior of penetration resistance (PR) of the probes of the west end-labeled S-1, S-2, S-7, S-12, S-16, and S-20 are shown in Figure 8; in probe S-1 it was possible to observe that the resistance of the soil is very low up to a depth of 5.10 m, likewise probes S-2, S-7, S-12, S-16 and S-20, located to the west of the cavity, show that the soil presents low resistance to penetration from the surface to a depth of 1.00 m and that the soil is competent starting at a depth of 4.50 m.

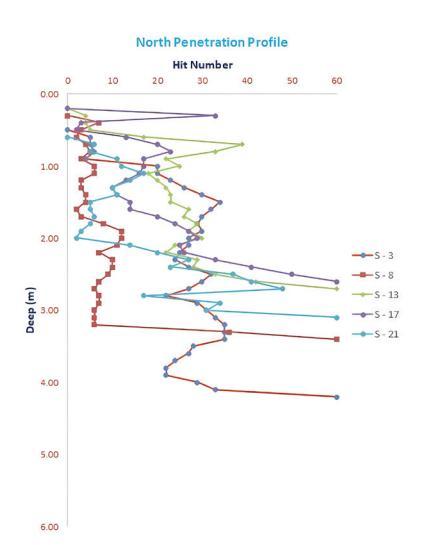
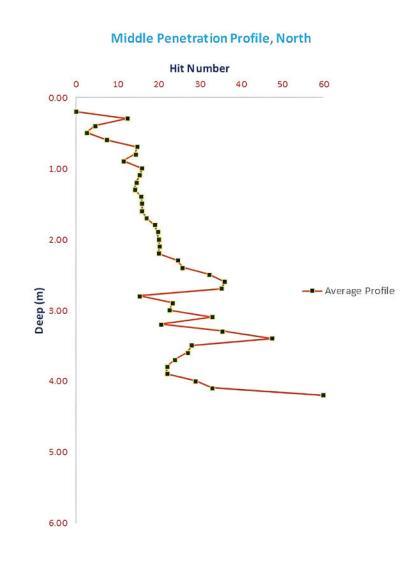
Figure 9. Probes at the north end

On the other hand, probes S-3, S-8, S-13, S-17, and S-21 (Figure 9), located on the north side, show that the PR is low from the surface up to a depth of 0.70 m, in S-8 it can be seen that the PR is low up to a depth of 3.20 m. In contrast, it was observed that the soil is competent starting at a depth of 4.20 m.

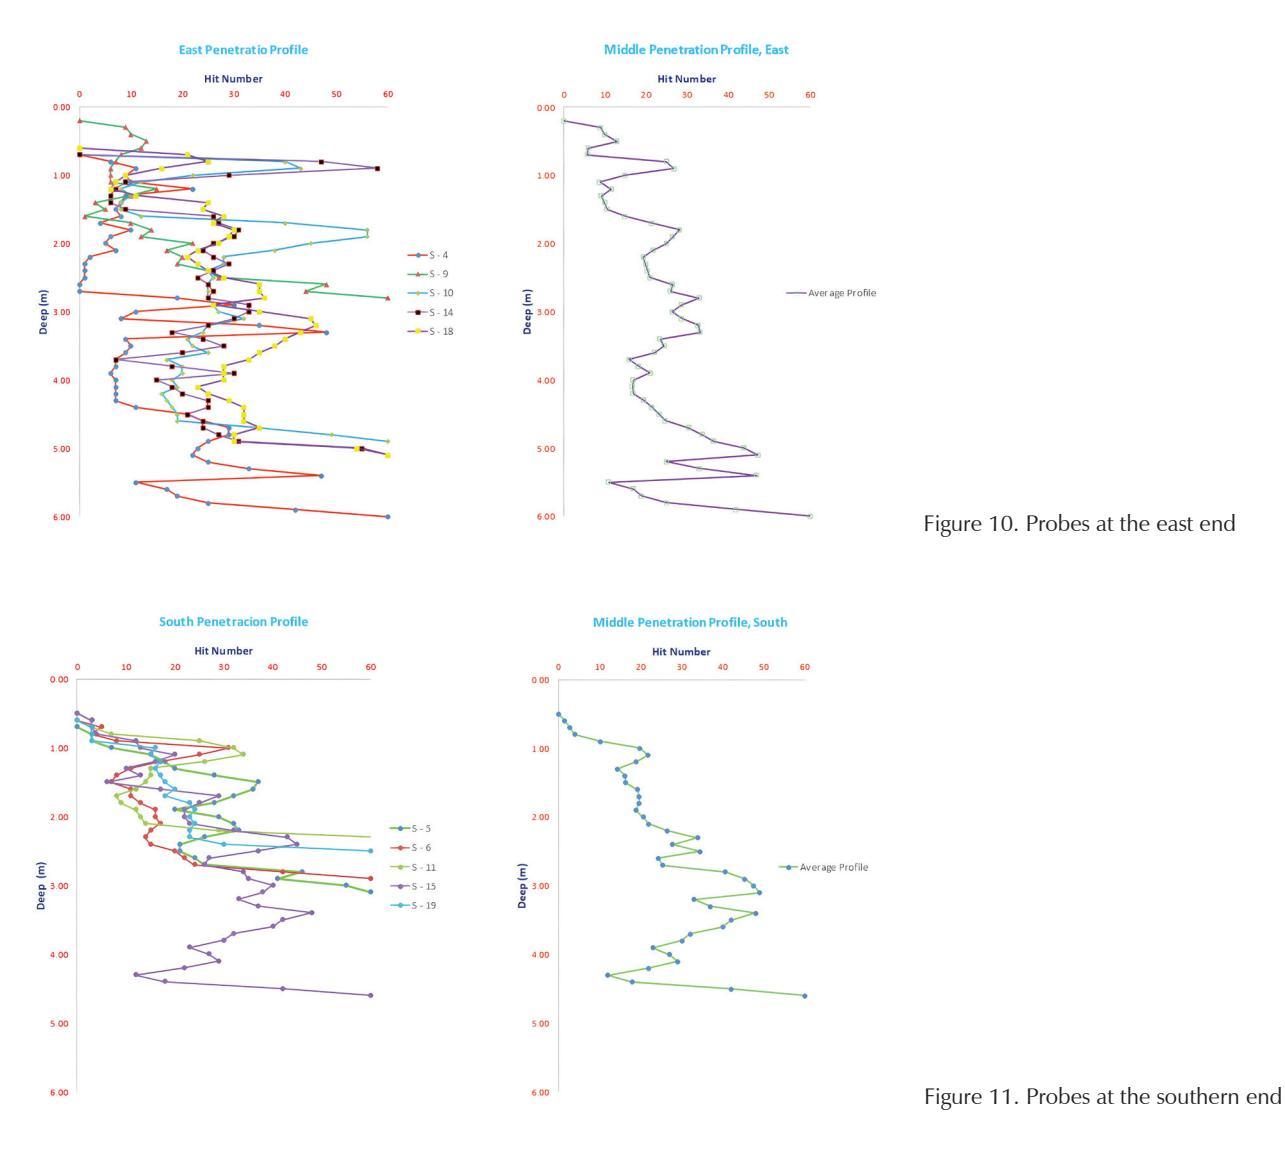
Figure 10 shows the east end, in probes S-4, S-9, S-10, S-14, and S-18, it is appreciated that the soil has low RP from the surface to 1.50 m in depth, particularly, S-4 has low RP and the soil is competent starting at 6.00 m deep.

Figure 11 presents the exploration of the south end with probes S-5, S-6, S-11, S-15, and S-19, here it can be observed that the soil presents low RP from the surface up to a depth of 0.90 m, and the soil is competent at 4.60 m deep.

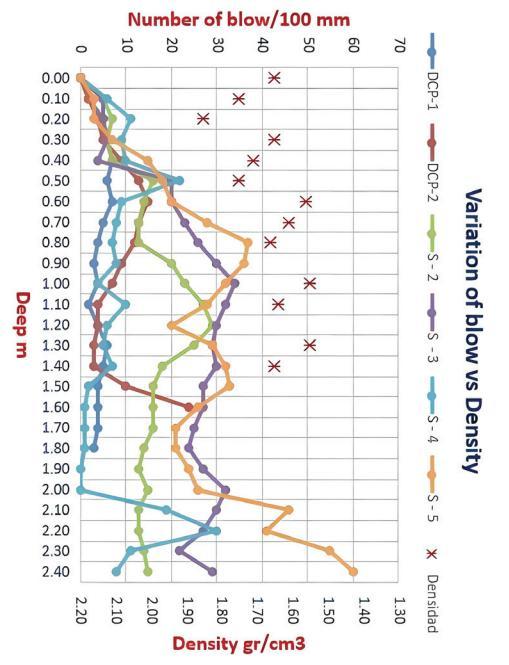
Figure 12. Comparison between the results obtained by (Abdulrahman *et al.,* 2015) and those obtained in Los Angeles

On the other hand, the PDC test is affected by the fines present, the moisture content, the granulometry and the vertical pressure acting on the column of the penetrometer bars (Deepika & Chakravarthi, 2012). Now it presents a comparison of the results obtained in this work, with those presented by (Abdulrahman et al., 2015), during the verification of soil densification and its homogeneity, of a property industrial of Saudi Arabia, obtained by means of the nuclear densimeter and the resistance to penetration obtained by means of the Manual Dynamic Penetrometer, respectively. These results were compared with the results of the S-2, S-3, S-4, and S-5 probes, developed in the community of Los Angeles, where it was possible to corroborate that the results of the Manual Dynamic Penetrometer were useful in the exploration of the subsoil and the identification of its homogeneity, as it was necessary to determine it, in the case study of the void formed at the intersection of the aforementioned streets (Figure 12).

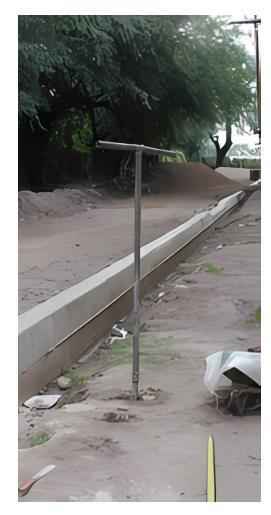
Figure 14. Soil sampling

To characterize the soil at the site of interest, sampling was done using a posting shovel, from the soil surface up to a depth of 4.80 m, as shown in Figure 14. The soil samples were transported to and tested in the laboratory.

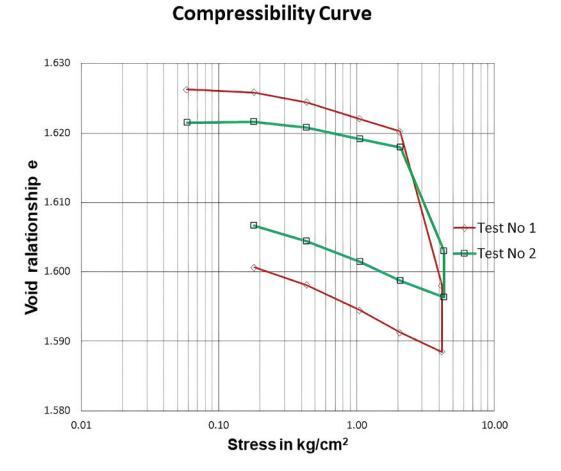
Figure 17. Collapsible behavior of the 2nd layer

To evaluate the likelihood of collapsing of this soil, the collapse index was determined according to the procedure stated by the ASTM-D-5333-03 (2003), the results are shown in Figure 17.

Based on Figure 17, and Table 2, it was determined that when the soil is at its natural moisture content, it can support up to 20 Ton/m² without exhibiting excessive deformations; however, if this soil is subjected to hyTable 2. Callenas index afthe 200 starting ast

dration, a collapse index of 0.31 can be reached, this is consistent with a soil slightly propensity to collapse.

- Particularly, the 2nd layer of soil shows significant resistance and little deformation when naturally moisturized; however, when hydrated, it may experience a slight propensity to collapse.

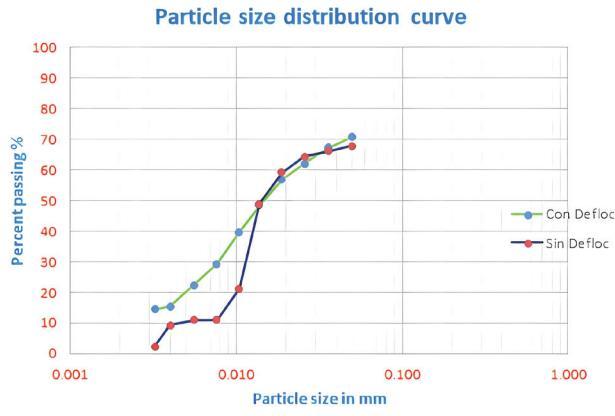
Figure 18. Grain size distribution of the fine fraction of the soil

To study the dispersive behavior of the soil, a double hydrometer grain size distribution analysis was performed, according to the ASTM 422-63 (2003), and the ASTM 4221-99 (1999), the results are shown in Figure 18.

Based on the procedure established by the ASTM 422-63 (2003), it was determined that the soil presented the behavior shown in Table 3, see too Maharaj & Paige, (2013).

With the information presented in Table 3, it was possible to say that only the 2nd stratum presents a dispersive behavior of intermediate degree.

- The soils located in the 2nd, 3rd, 4th, and 5th strata have an appreciable content of clayey fines, and by applying the Double Hydrometer test it was possible to discover that the soil of the 2nd stratum is susceptible to dispersion, to an intermediate degree.

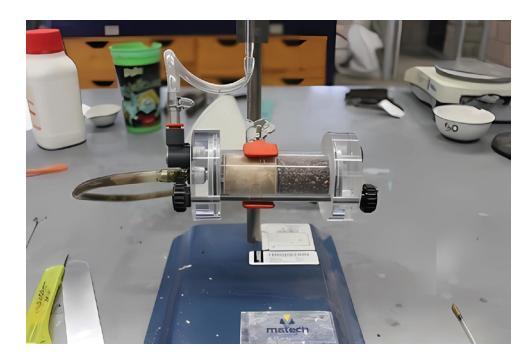
Figure 19. Pinhole test

To identify the soils present, two Pinhole tests (Figure 19) were performed on the soil located in the 2nd stratum, since it is an alkaline soil, the results are presented in Table 4.

Although the soil was classified as ND1 (*non-dispersive*) type, any fissure in the soil subjected to the water flow may experience erosion, so suffusion could appear inside the soil (Maharaj & Green, 2015).

- In addition, the pinhole test helped determine that the soil of the 2nd layer is not susceptible to dispersion, however, it is susceptible to erosion.

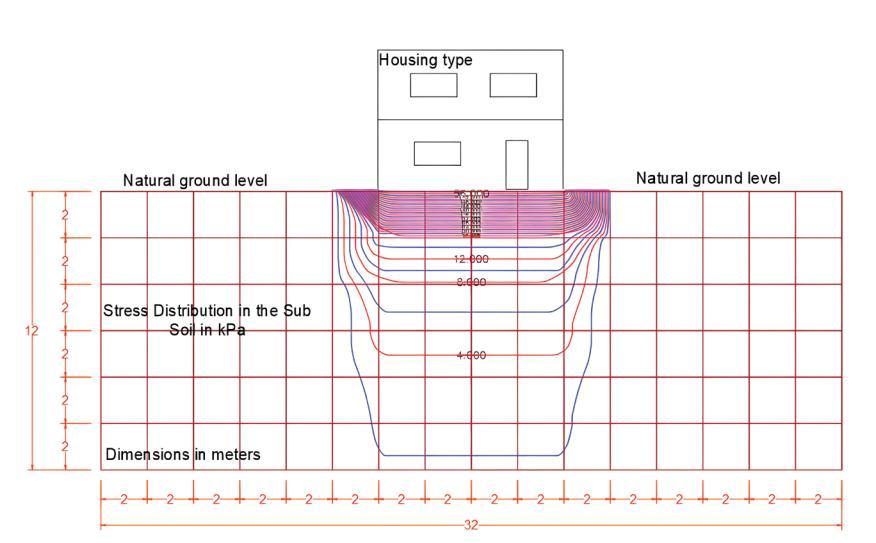
Figure 20. Stress distribution in the subsoil under loads of a platform supporting the structure of a 2-story house. The curves are the isobars obtained with the nodes or stress interpolation points

To know the stress distribution of the underground in the area where the cavity appeared, an overload pressure of 60 kPa (6.12 Ton/m^2) was applied to a two-floor low-income dwelling, as shown in Figure 20.

The distribution of stresses in the subsoil shown in Figure 20 represents the case of a soil platform 2.00 m high with a specific weight of 17.17 kN/m³, that supports the structure of a 2-storey house, with an applied pressure on the ground of the site of 94.34 kPa. It was observed that due to the theory of elasticity, the stresses applied on the surface dissipate at a depth of 3.50 m, that is, they are reduced to 10 %, and 8.50 m before the groundwater level is reached, therefore, the possibility that the caverns could collapse is not considered, due to the overload imposed, in case there were.
